TWR-17543-1

# **Flight Motor Set 360T004 (STS-30R) Final Report**

**Volume I  
(System Overview)  
September 1989**

***Thiokol* CORPORATION**  
**SPACE OPERATIONS**

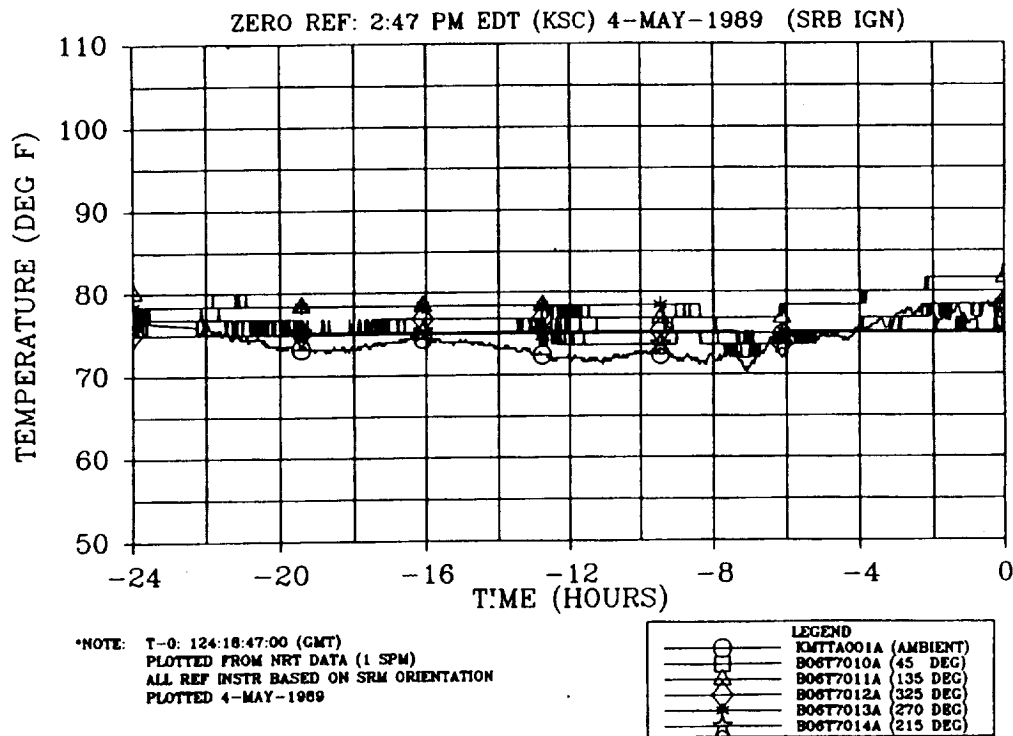
Figure 4.8-58. LH SRM Prelaunch Case Acreage Temperature at Station 931.5 (overlaid with ambient)

This chilling effect occurred on the three forwardmost 270-deg GEI locations--Stations 931.5, 1091.5, and 1411.5. This determination was made by first noting that the temperatures on the RH and LH motors at these three locations were identical during nonfilled conditions. Next, a comparison was made to determine the temperature change (relative to ambient) of these six locations during and following ET loading. It was seen that the LH motor, at these locations,

This cooling should not be considered serious because the actual case surface temperature was never more than 3°F lower than the ambient temperature. It should also be noted that the GOX venting played no part in this LH motor inboard location cooling occurrence.
